# TREE ASSESSMENT REPORT ISSUED FOR 100% SUBMISSION

DOWNTOWN SEWER SEPARATION - PHASE 4  
YORK ST. - CLARENCE ST. TO COLBORNE ST.  
LONDON, ONTARIO

PREPARED BY: RON KOUDYS LANDSCAPE  
ARCHITECTS INC

DATE: SEPTEMBER, 2023

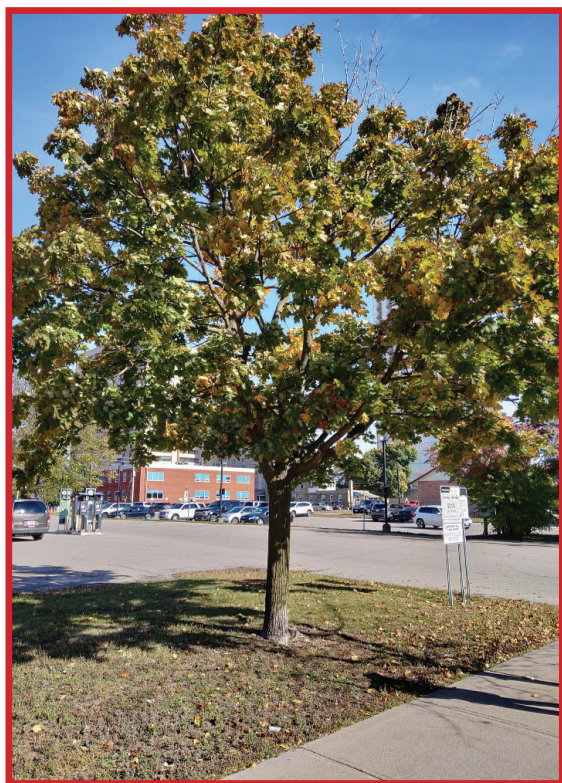
TREE ID #1 - NORWAY MAPLE  
City ROW at 342 York Street

| GENERAL INFORMATION | | | | SIZE | | HEALTH & CONDITION | | | | RECOMMENDATIONS | | |
|---|---|---|---|---|---|---|---|---|---|---|---|---|
| 1 | <i>Acer platanoides</i> | Norway Maple | City ROW at 342 York Street | 30 | 4 | 4 | Good | Good | Circling roots | Minor conflict with road reconstruction | Remove | Construction conflict and tree condition |

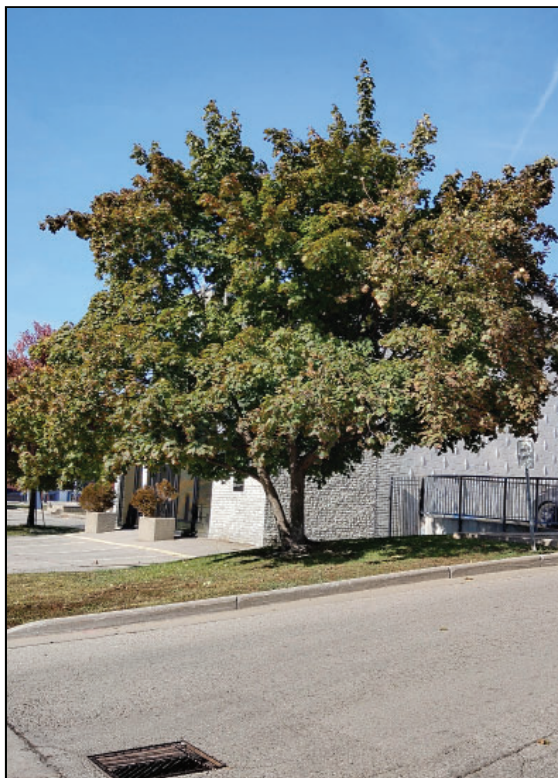
TREE ID #7 - NORWAY MAPLE  
City Row at 323 Colborne Street

| GENERAL INFORMATION | | | | SIZE | | HEALTH & CONDITION | | | | RECOMMENDATIONS | | |
|---|---|---|---|---|---|---|---|---|---|---|---|---|
| 7 | <i>Acer platanoides</i> | Norway Maple | City ROW at 323 Colborne Street | 36, 14 | 6 | 5 | Fair | Poor | Multi-stem 2, exposed damaged surface roots, basal cavity forming, frass | Minor conflict with road reconstruction | Preserve | Tree protection barrier |

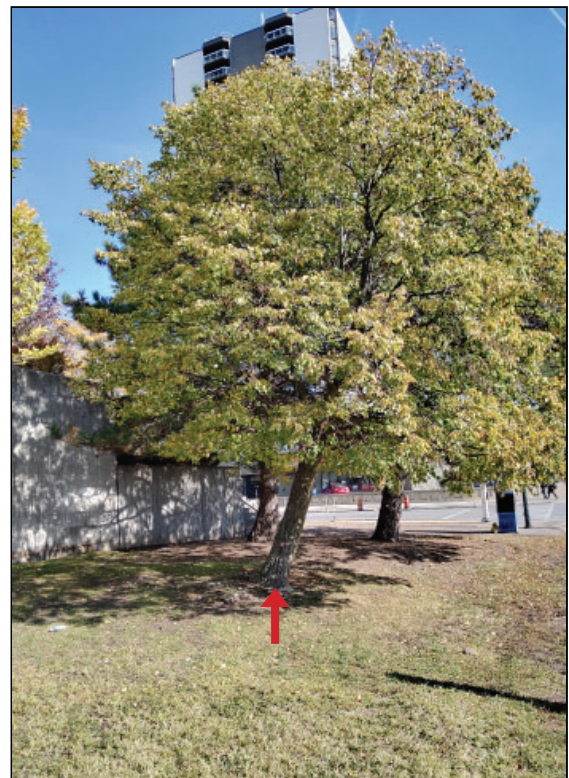
TREE ID #12 - LITTLE LEAF LINDEN  
City ROW at 323 Colborne Street

| GENERAL INFORMATION | | | | SIZE | | HEALTH & CONDITION | | | | RECOMMENDATIONS | | |
|---|---|---|---|---|---|---|---|---|---|---|---|---|
| 12 | <i>Tilia cordata</i> | Little Leaf Linden | City ROW at 323 Colborne Street | 30 | 3 | 5 | Good | Good | Lean south east, exposed damaged surface roots, cavity forming | Minor conflict with road reconstruction | Preserve | Tree protection barrier |

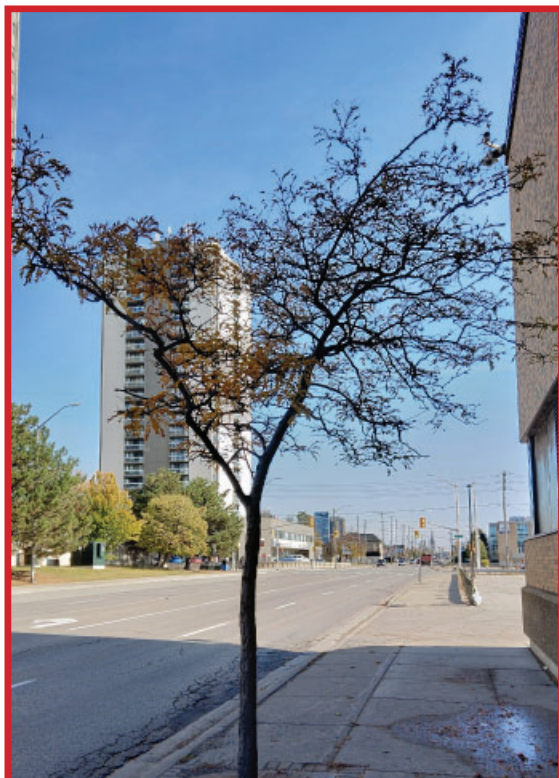
TREE ID #15 - HONEY LOCUST  
City ROW at 369 York Street

| GENERAL INFORMATION | | | | SIZE | | HEALTH & CONDITION | | | | RECOMMENDATIONS | | |
|---|---|---|---|---|---|---|---|---|---|---|---|---|
| 15 | <i>Gleditsia triacanthos var. inermis</i> | Honey Locust | City ROW at 369 York Street | 11 | 2 | 5 | Good | Good | Stunted | Conflict with road reconstruction | Remove | Construction conflict and tree condition |

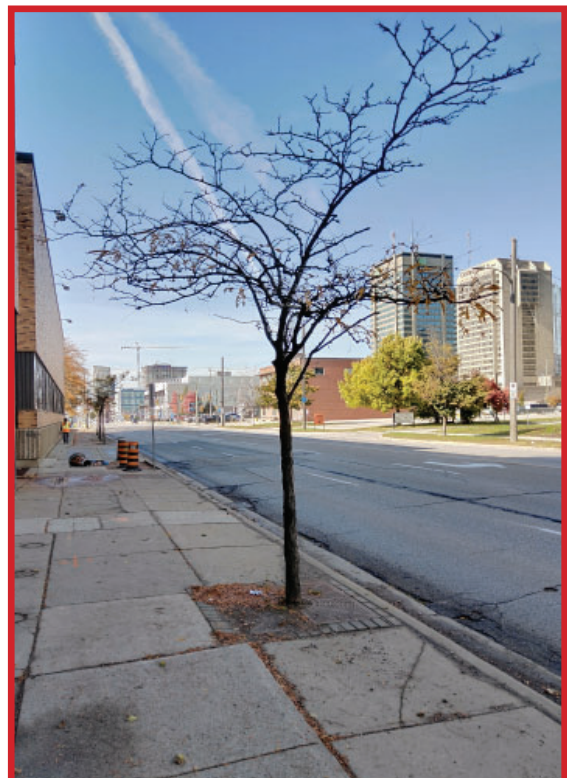
TREE ID #16 - HONEY LOCUST  
City ROW at 369 York Street

| GENERAL INFORMATION | | | | SIZE | | HEALTH & CONDITION | | | | RECOMMENDATIONS | | |
|---|---|---|---|---|---|---|---|---|---|---|---|---|
| 16 | <i>Gleditsia triacanthos var. inermis</i> | Honey Locust | City ROW at 369 York Street | 11 | 1.5 | 3 | Fair | Good | Basal wound, stunted | Conflict with road reconstruction | Remove | Construction conflict and tree condition |

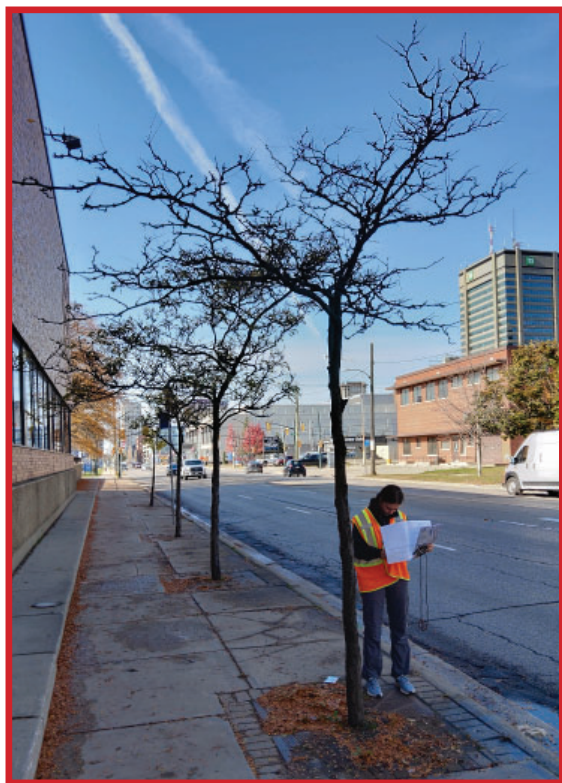
TREE ID #17 - HONEY LOCUST  
City ROW at 369 York Street

| GENERAL INFORMATION | | | | SIZE | | HEALTH & CONDITION | | | | RECOMMENDATIONS | | |
|---|---|---|---|---|---|---|---|---|---|---|---|---|
| 17 | <i>Gleditsia triacanthos var. inermis</i> | Honey Locust | City ROW at 369 York Street | 10 | 1 | 3 | Good | Good | Basal wound, stunted | Conflict with road reconstruction | Remove | Construction conflict and tree condition |

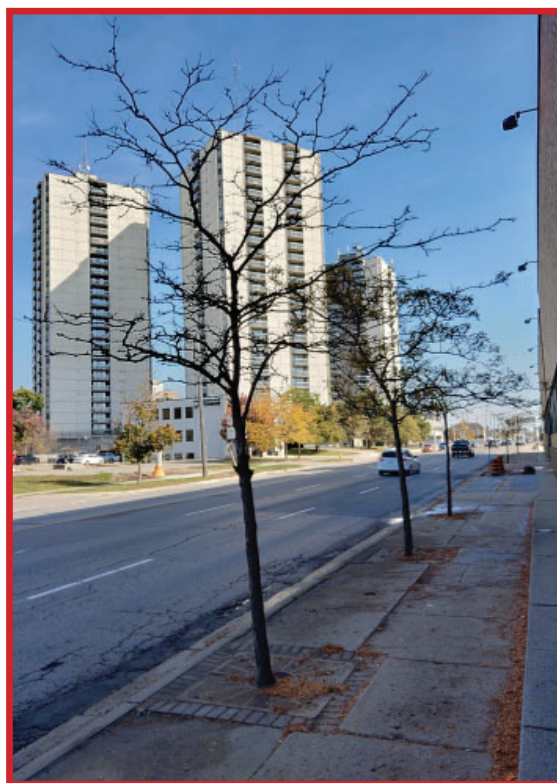
TREE ID #18 - HONEY LOCUST  
City ROW at 369 York Street

| GENERAL INFORMATION | | | | SIZE | | HEALTH & CONDITION | | | | RECOMMENDATIONS | | |
|---|---|---|---|---|---|---|---|---|---|---|---|---|
| 18 | <i>Gleditsia triacanthos var. inermis</i> | Honey Locust | City ROW at 369 York Street | 12 | 1.5 | 5 | Good | Good | Epicormic growth | Conflict with road reconstruction | Remove | Construction conflict and tree condition |

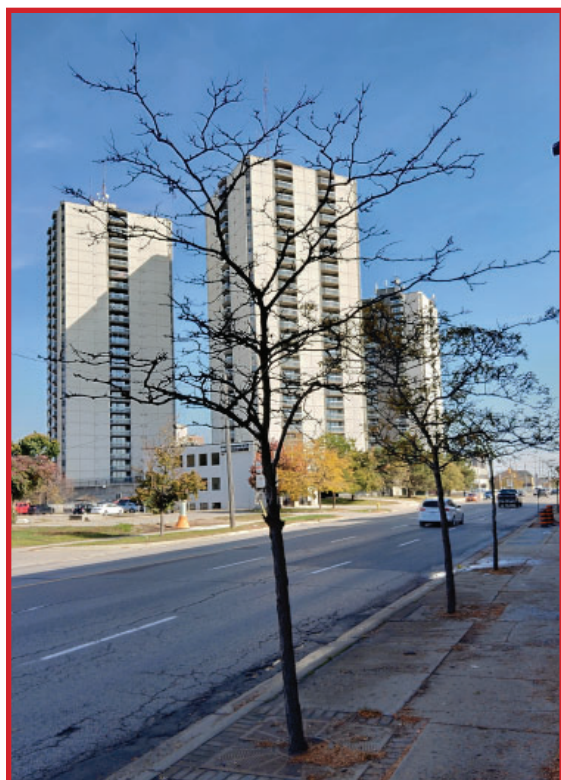
TREE ID #19 - HONEY LOCUST  
City ROW at 369 York Street

| GENERAL INFORMATION | | | | SIZE | | HEALTH & CONDITION | | | | RECOMMENDATIONS | | |
|---|---|---|---|---|---|---|---|---|---|---|---|---|
| 19 | <i>Gleditsia triacanthos var. inermis</i> | Honey Locust | City ROW at 369 York Street | 11 | 1.5 | 4 | Good | Good | Trunk wound, epicormic growth trunk split 1 meter from base | Conflict with road reconstruction | Remove | Construction conflict and tree condition |

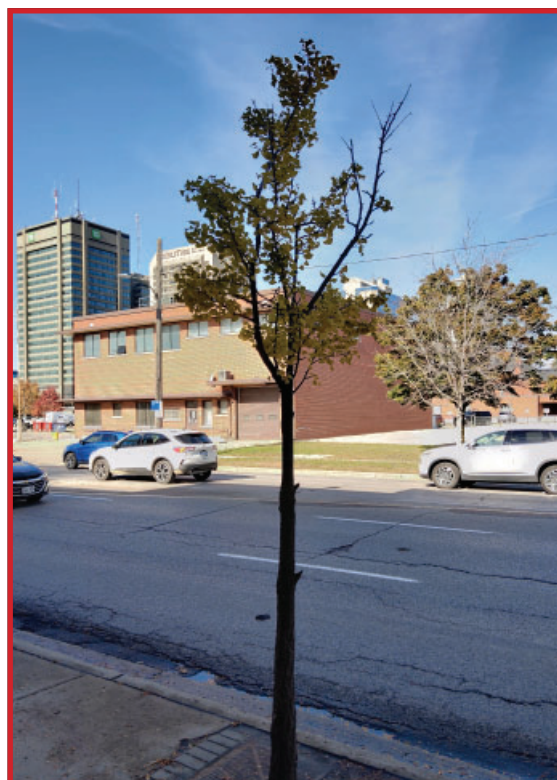
TREE ID #20 - GINKGO  
City ROW at 369 York Street

| GENERAL INFORMATION | | | | SIZE | | HEALTH & CONDITION | | | | RECOMMENDATIONS | | |
|---|---|---|---|---|---|---|---|---|---|---|---|---|
| 20 | <i>Ginkgo biloba</i> | Ginkgo | City ROW at 369 York Street | 9 | 1 | 4 | Good | Good | Stunted, trunk wound, cavity forming | Conflict with road reconstruction | Remove | Construction conflict and tree condition |

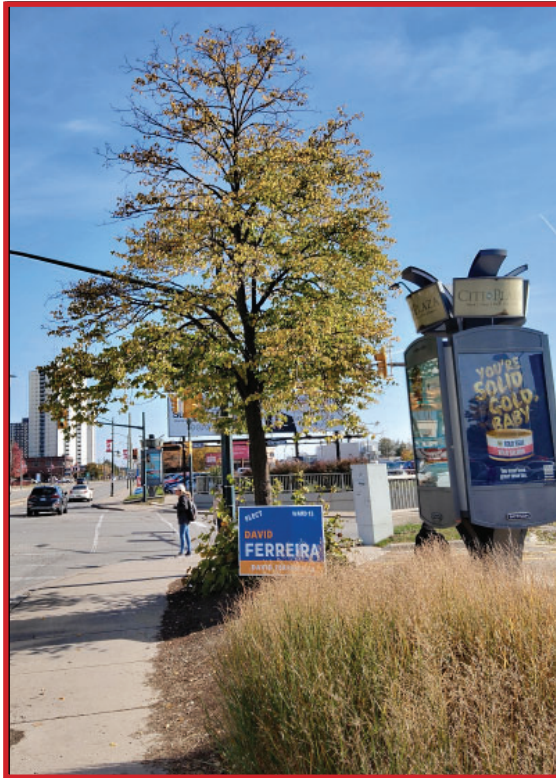
TREE ID #21 - LITTLE LEAF LINDEN  
267 York Street

| GENERAL INFORMATION | | | | SIZE | | HEALTH & CONDITION | | | | RECOMMENDATIONS | | |
|---|---|---|---|---|---|---|---|---|---|---|---|---|
| 21 | <i>Tilia cordata</i> | Little Leaf Linden | 267 York Street | 26 | 3 | 5 | Good | Good | Mature epicormic growth a base | Conflict with sidewalk reconstruction | Remove | Construction conflict and tree condition |

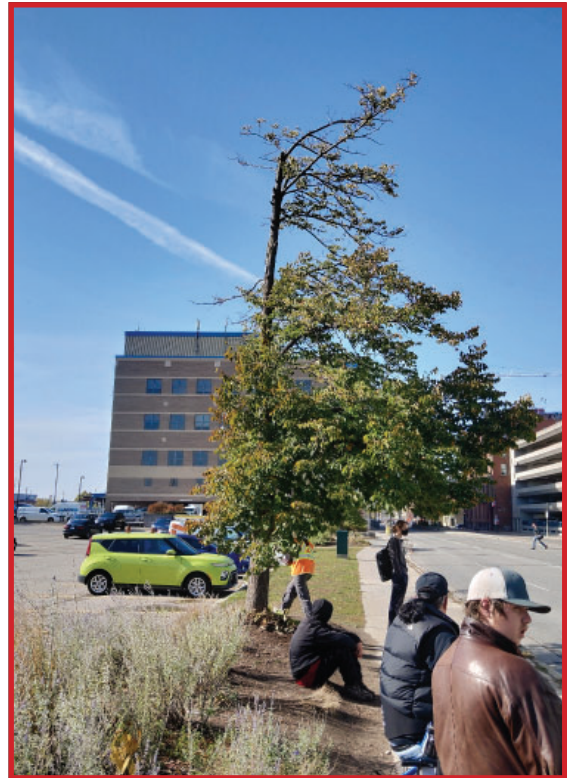
TREE ID #22 - LITTLE LEAF LINDEN  
267 York Street

| GENERAL INFORMATION | | | | SIZE | | HEALTH & CONDITION | | | | RECOMMENDATIONS | | |
|---|---|---|---|---|---|---|---|---|---|---|---|---|
| 22 | <i>Tilia cordata</i> | Little leaf Linden | 267 York Street | 28 | 3 | 3 | Poor | Fair | Epicormic growth, dead leader, exposed damaged roots, sitting high in garden bed | Conflict with sidewalk reconstruction | Remove | Construction conflict and tree condition |

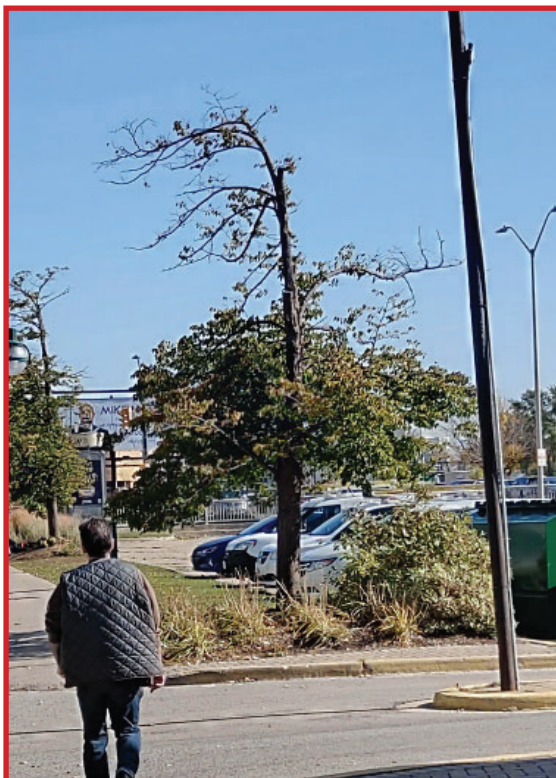
TREE ID #23 - LITTLE LEAF LINDEN  
267 York Street

| GENERAL INFORMATION | | | | SIZE | | HEALTH & CONDITION | | | | RECOMMENDATIONS | | |
|---|---|---|---|---|---|---|---|---|---|---|---|---|
| 23 | <i>Tilia cordata</i> | Little Leaf Linden | 267 York Street | 29 | 2.5 | 2 | Poor | Fair | Dead leader | Conflict with sidewalk reconstruction | Remove | Construction conflict and tree condition |
