# Challenges of Silverwoods Park

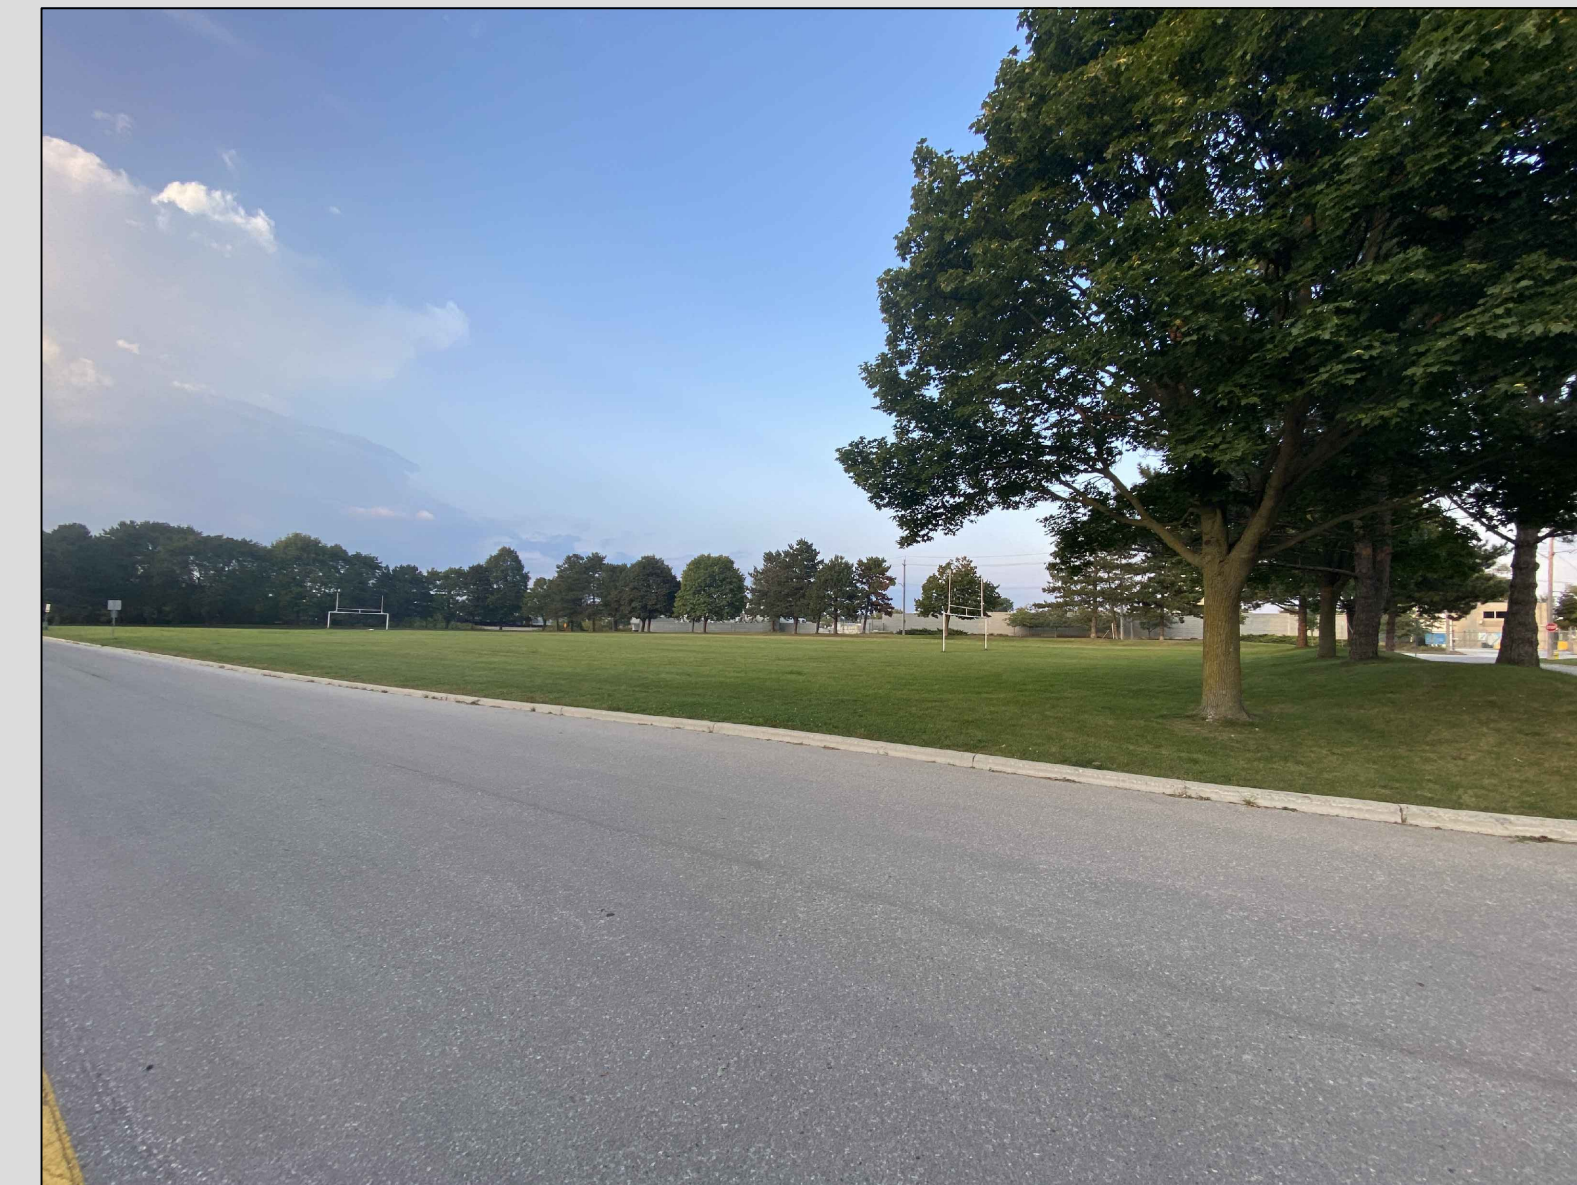
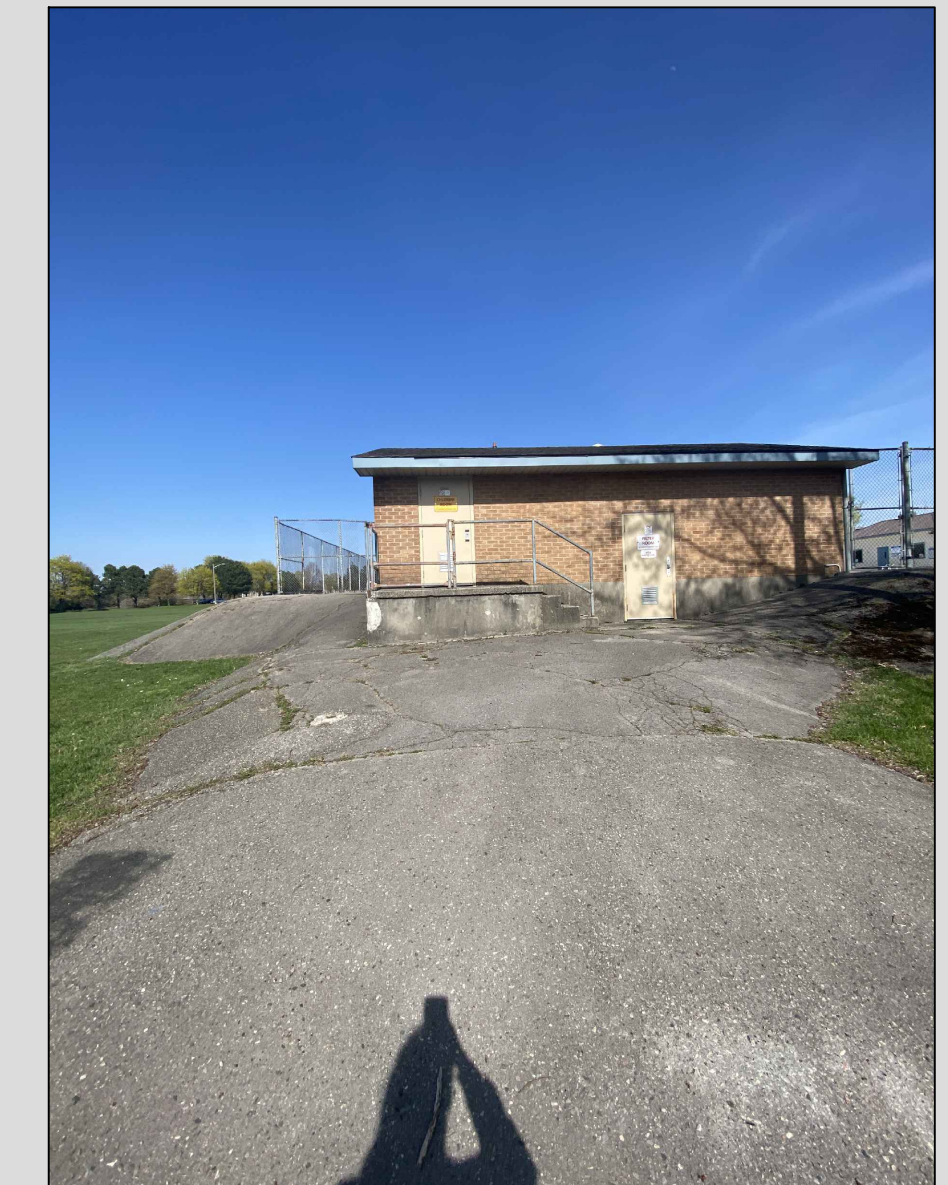
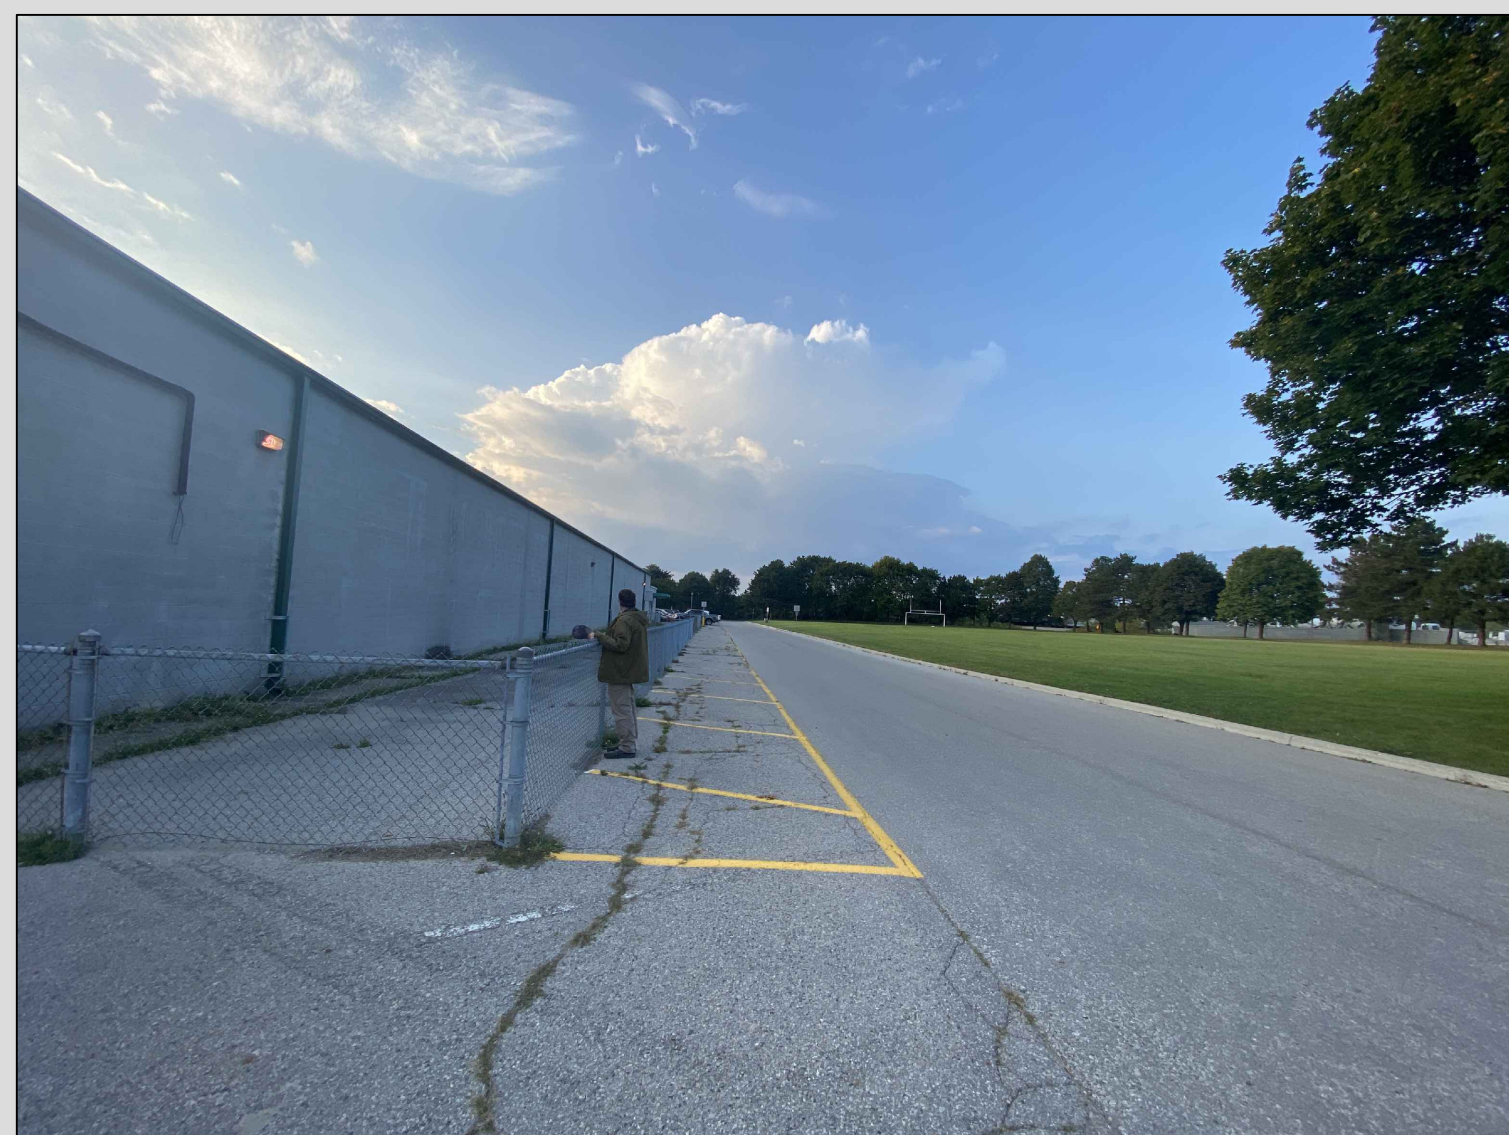
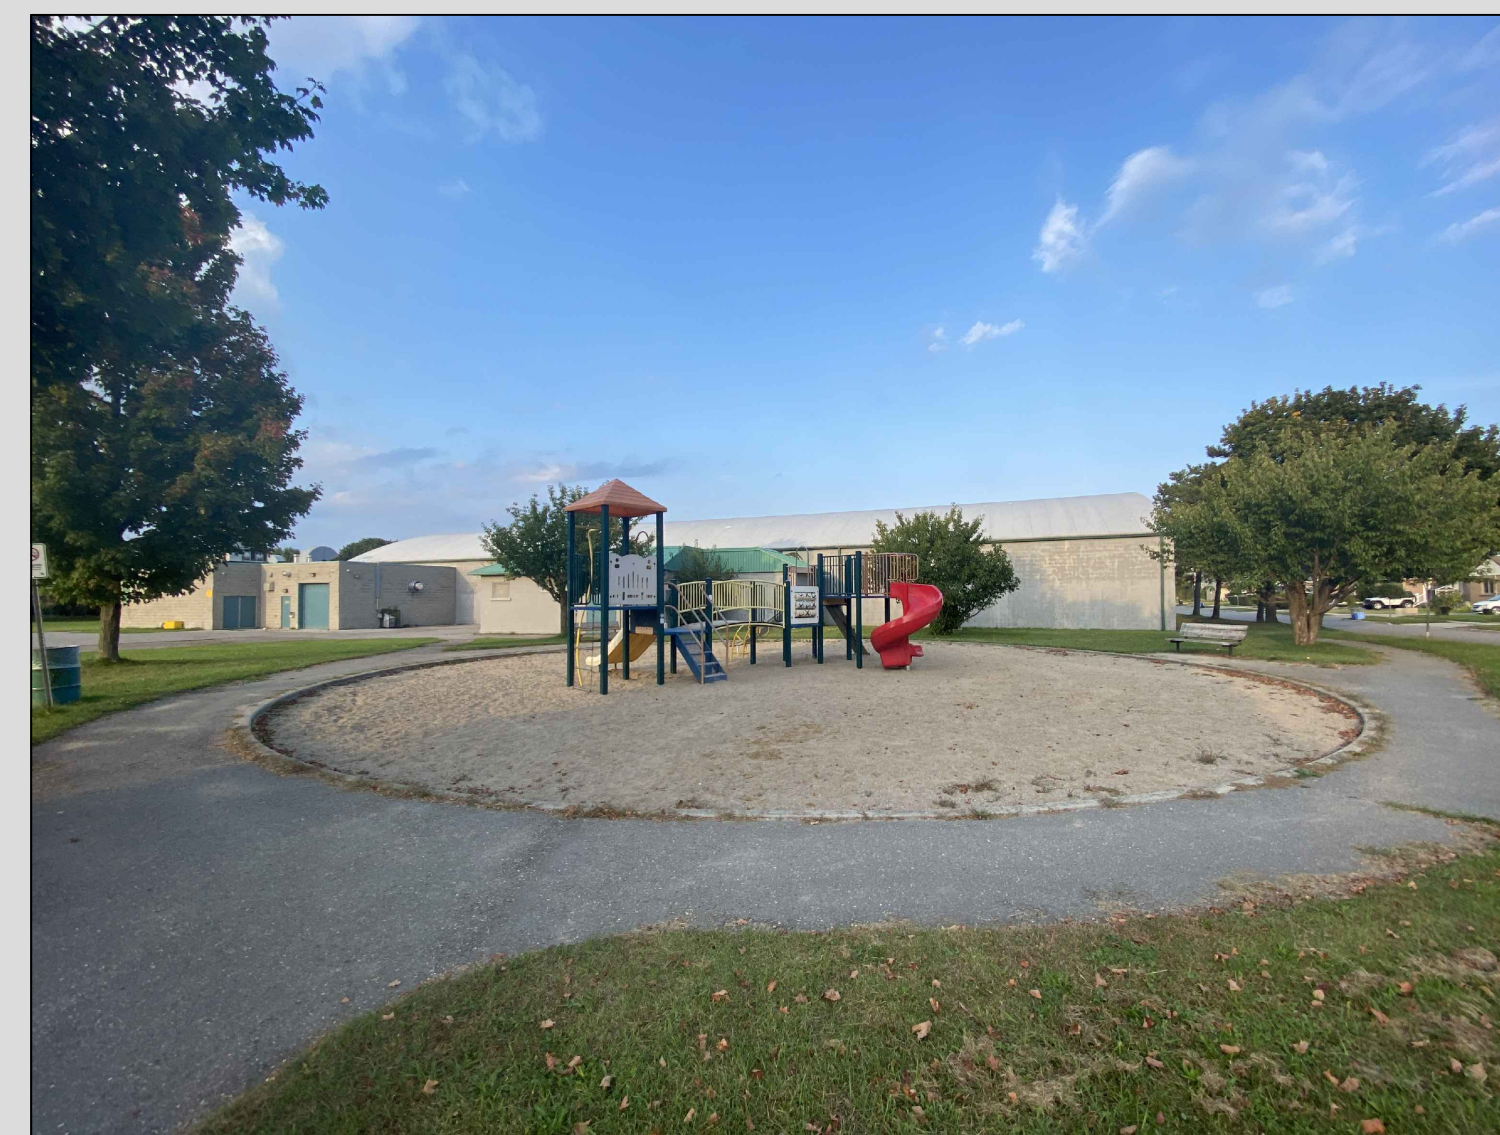
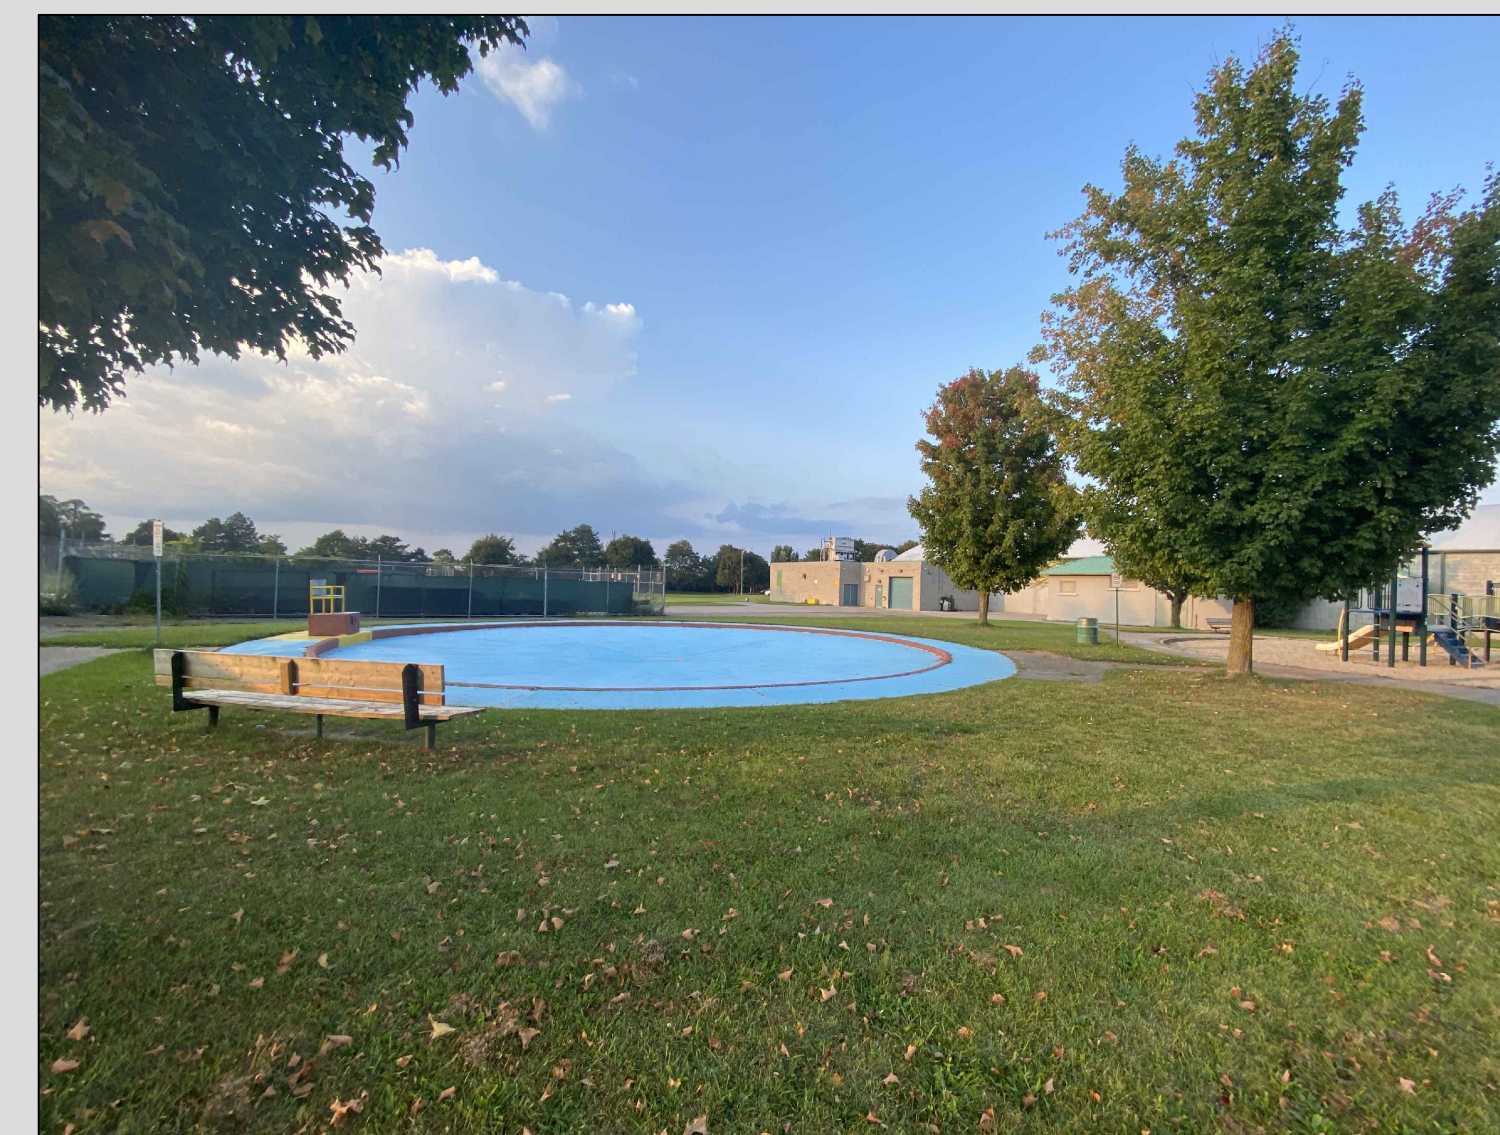
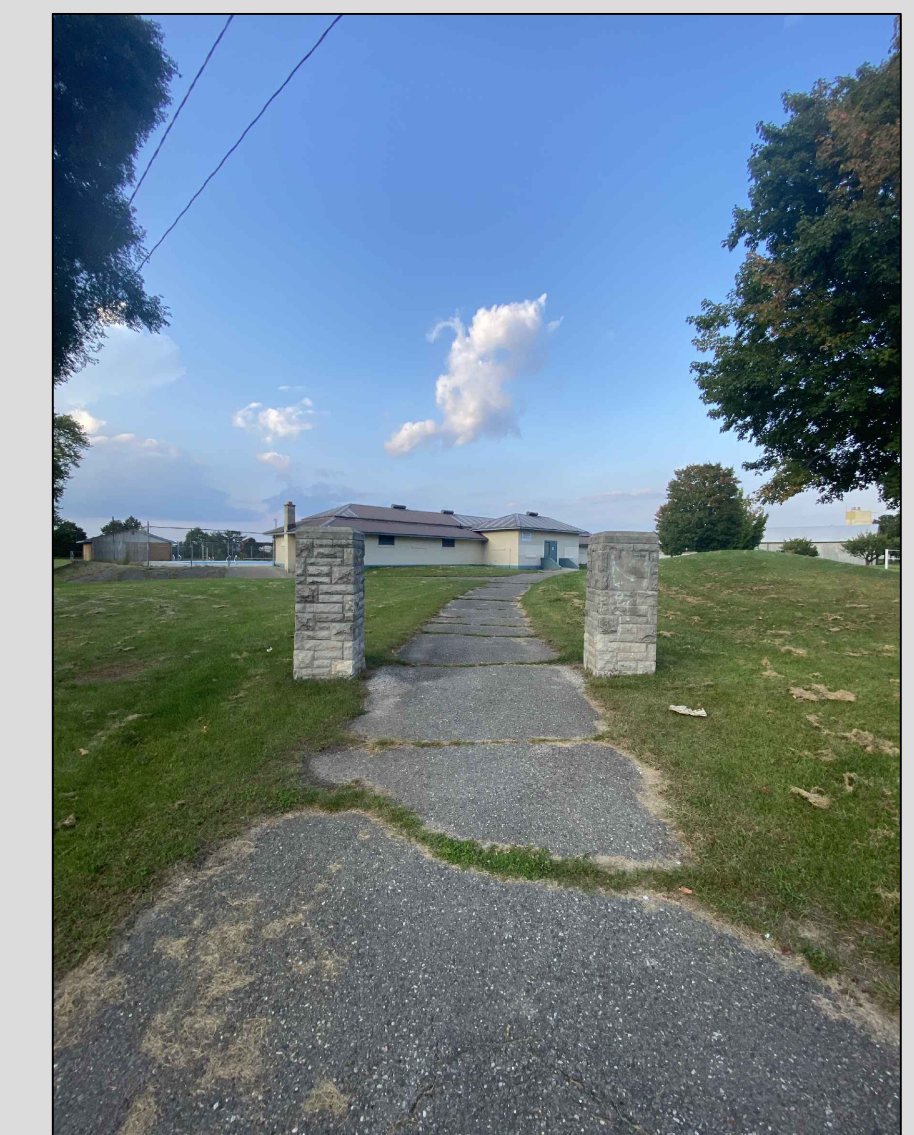
1. Existing parking lot is a challenging shape and takes potential space away from the Park block
2. Existing pathways are past their life expectancy and need to be replaced
3. Existing playground does not currently meet the district park standard and is close to the road
4. Existing berm at the front of the property blocks sight lines into the park
5. Existing site lighting does not meet current standards
6. Existing asphalt areas serve the past arena use of the site
7. Snow and ice slides off the existing building roof
8. The pathway along the south side of the main building is very narrow and a challenging drainage area
9. There are no existing sidewalks around the perimeter of the site
